March 25, 2014

Re: Asbestos Contamination Assessment

On March 11, 2014 Churchill Environmental performed a Contamination Assessment at 68 Main St. Canajoharie, NY in Buildings 38, 45, and 57 due to the disturbance of Asbestos Aircell Pipe Insulation caused by the sub contractor M&M Consulting & Contracting out of Jersey City, New Jersey. The sub contractor was cutting out copper pipes, wiring, and steel. The assessment was performed by Ray Churchill, a certified USEPA/NYS DOL Building Inspector/Project Monitor and Project Designer.

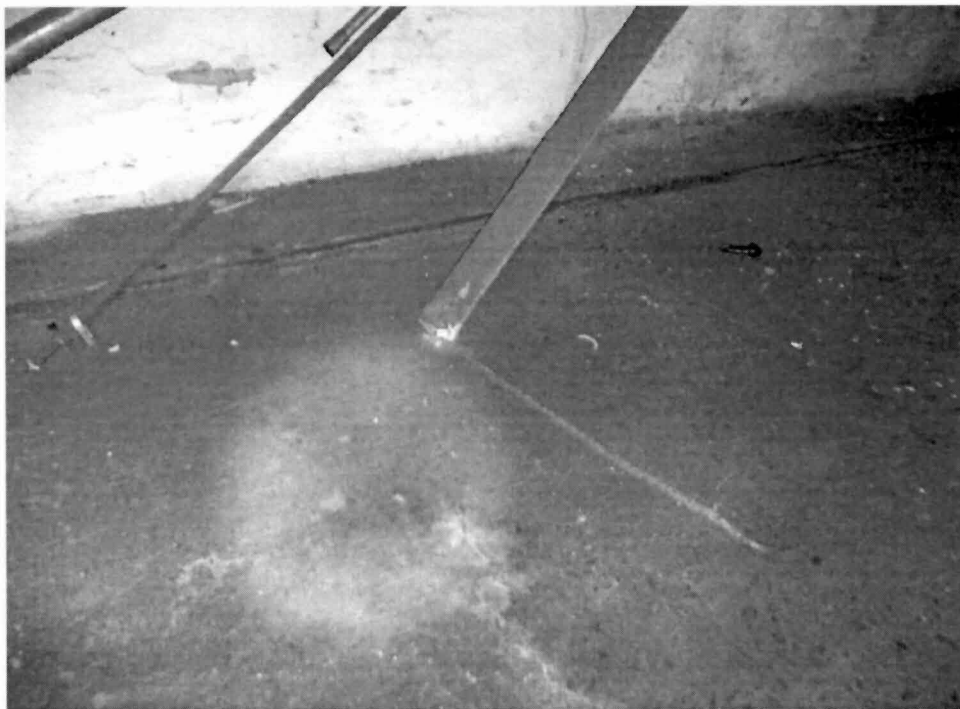
In Building 54, the Pedestrian Walkway a pipe with ACM Aircell under the roof rafters was cut with one end falling to the floor, the other end stayed suspended. The visual inspection found approximately 4' of debris where the pipe dragged after hitting the floor. Four TEM Micro-Vac Samples were taken approximately 15' out from the pipe to see if any asbestos fibers had migrated outward from the pipe. Of the four samples, one had two ACM Chrysotile Fibers in it. The Micro-Vac's were taken using a 100cm squared template and a low-vol pump running at 2 L/M for two minutes. Based on this finding the Contaminated area was moved back another 15' feet from that sample. That entire section of the hallway is considered contaminated. This is Incidental Disturbance #1. See the attached lab results, floor plans, and photos.

The Cut ACM Pipe in the Walkway

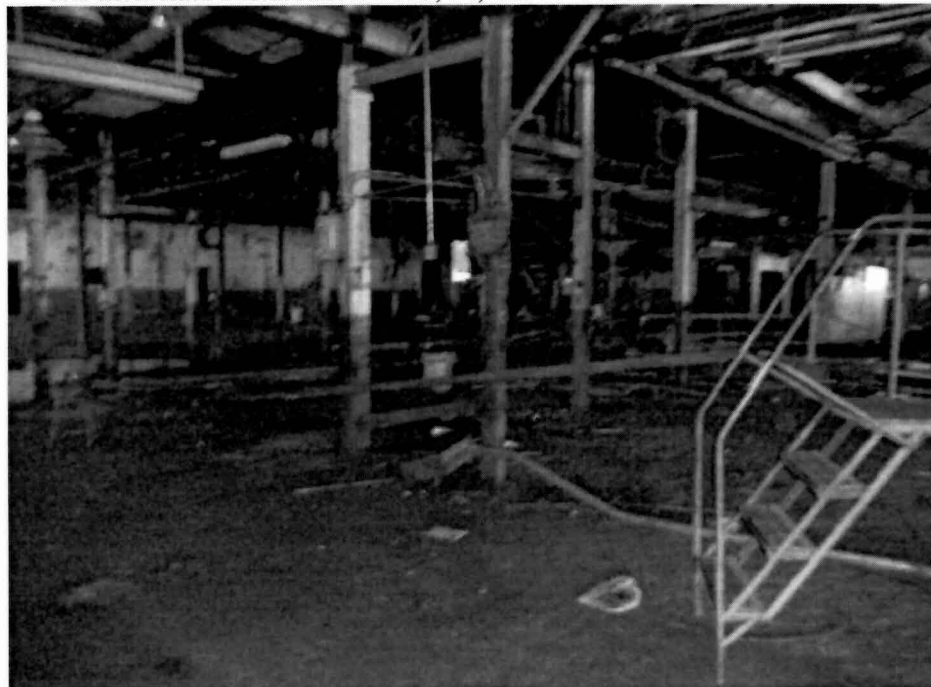
The Disturbance where the Concrete Deck was cut down covers approximately a 30'x 70' area. ACM Debris from the pipes above in the ceiling was found and one Micro-Vac Sample had 1 Chrysotile Fiber in it. The other Micro-Vac's did not have any asbestos in them. The Contaminated Area was determined based on the Visual Inspection, Bulk Samples, and Micro-Vac Samples taken. Where the last seen suspected ACM was seen the area was taken out an additional 1' in each direction. This is Incidental Disturbance #3, #4, and #5.

The Incidental Disturbances of #3, #4, and #5 Combined as one work area.

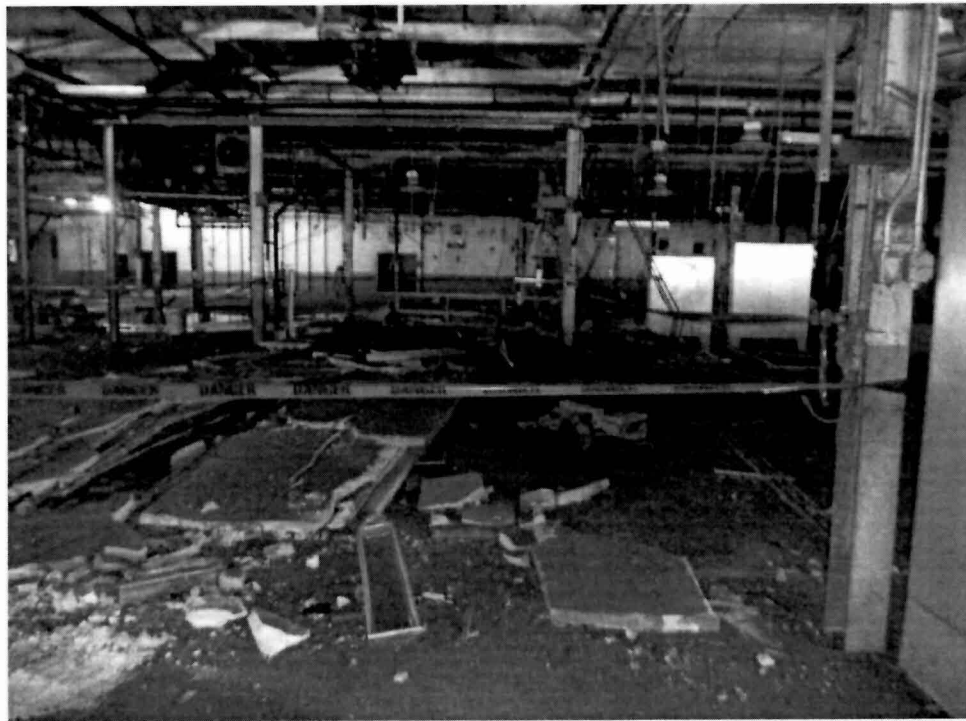
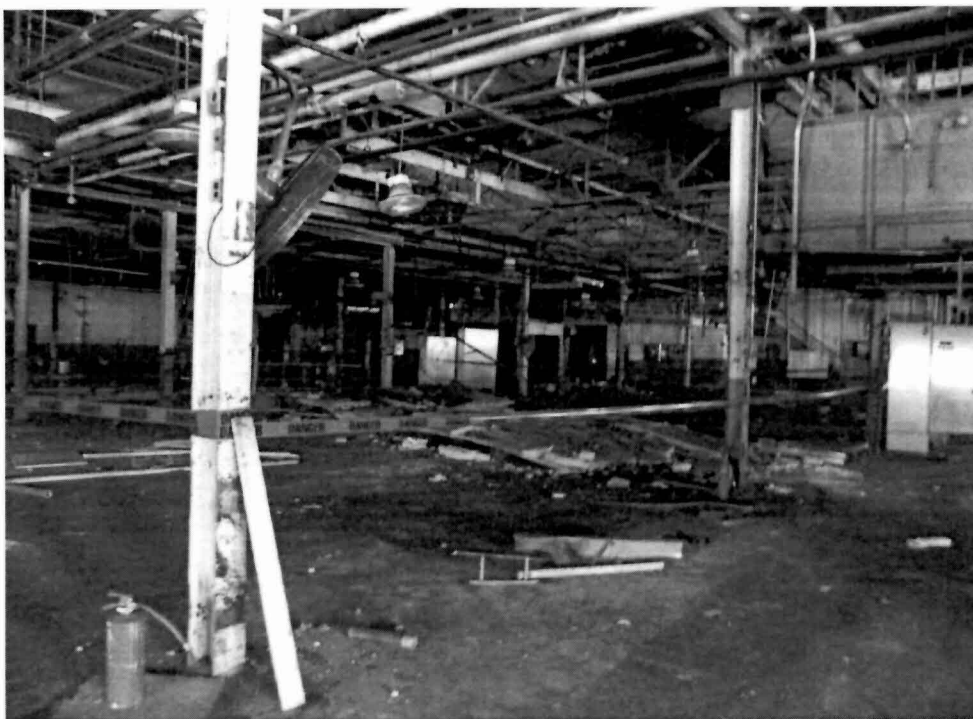
The Damaged Aircell from the removal of the Upper Concrete Deck
